Clinical Case: Reattachment of a Coronal Fragment in an 11-Year-Old Patient

Case Description

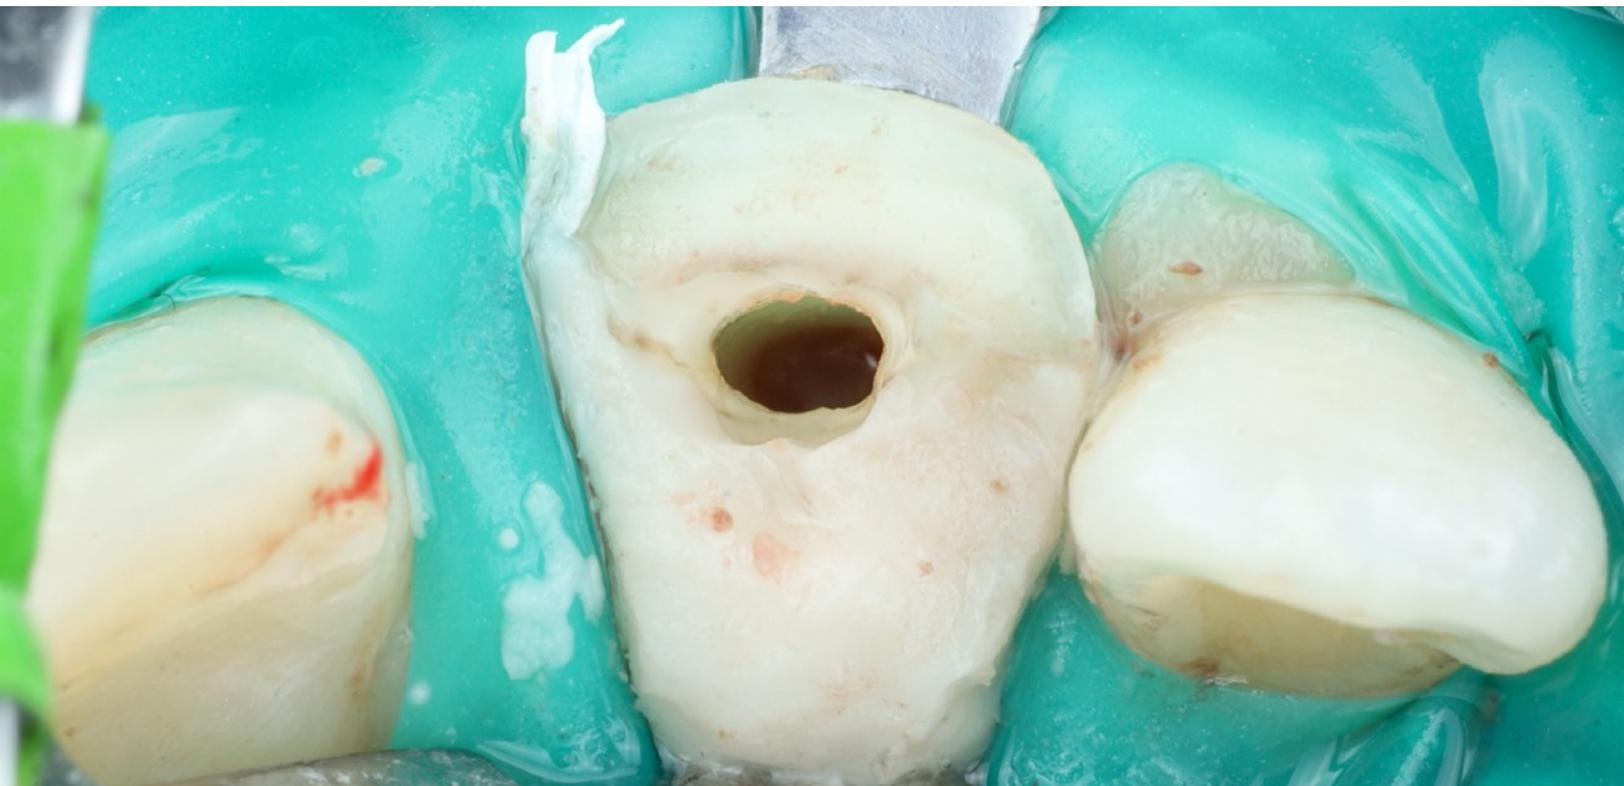
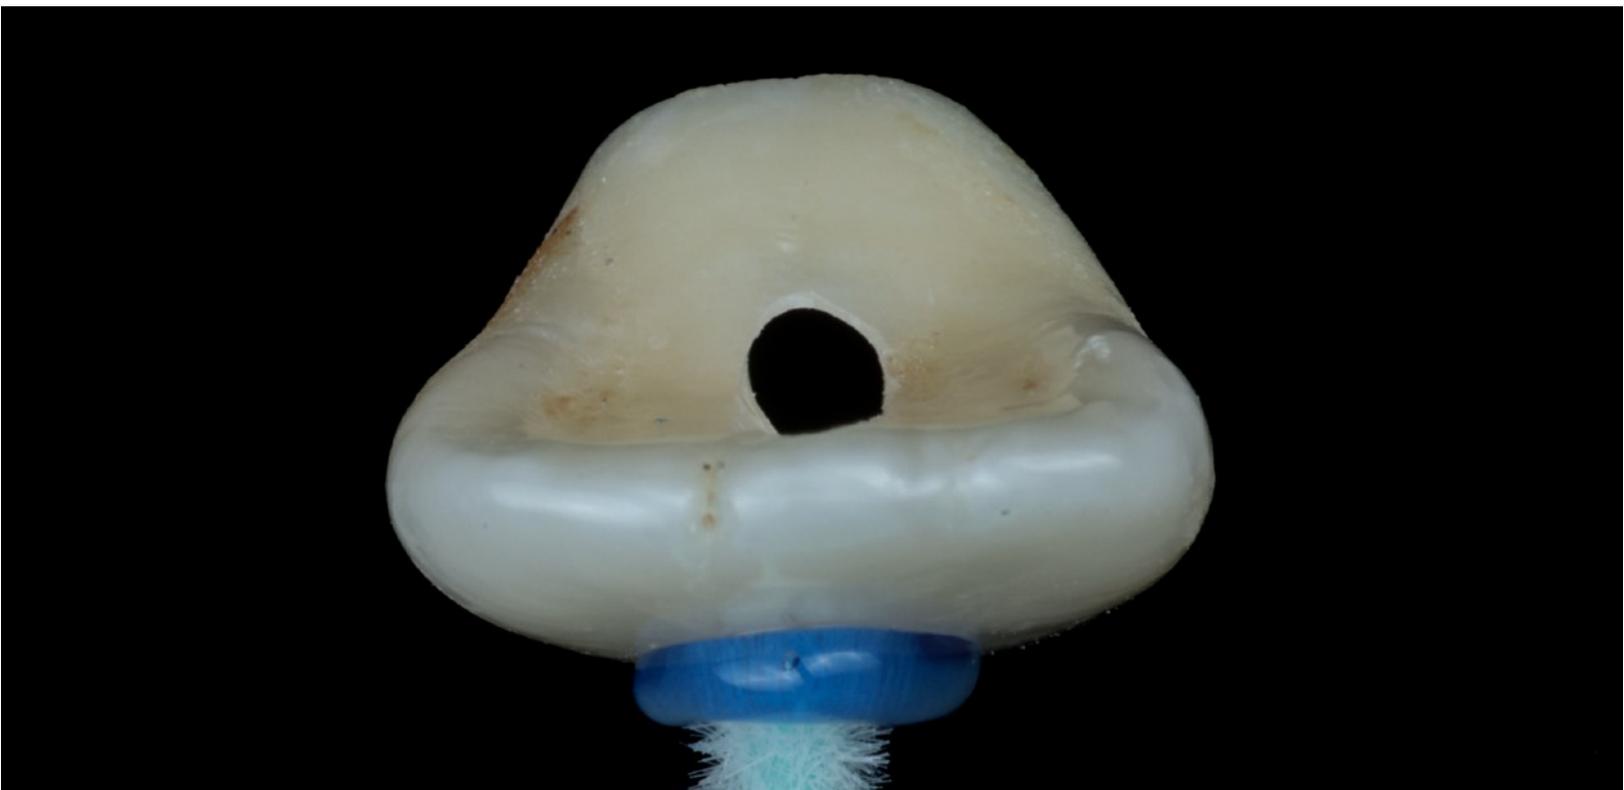
Pe această poză clema încă nici așa nu a reușit să intre până în profunzime. După care s-a poziționat corect clema apoi a urmat reconstituirea

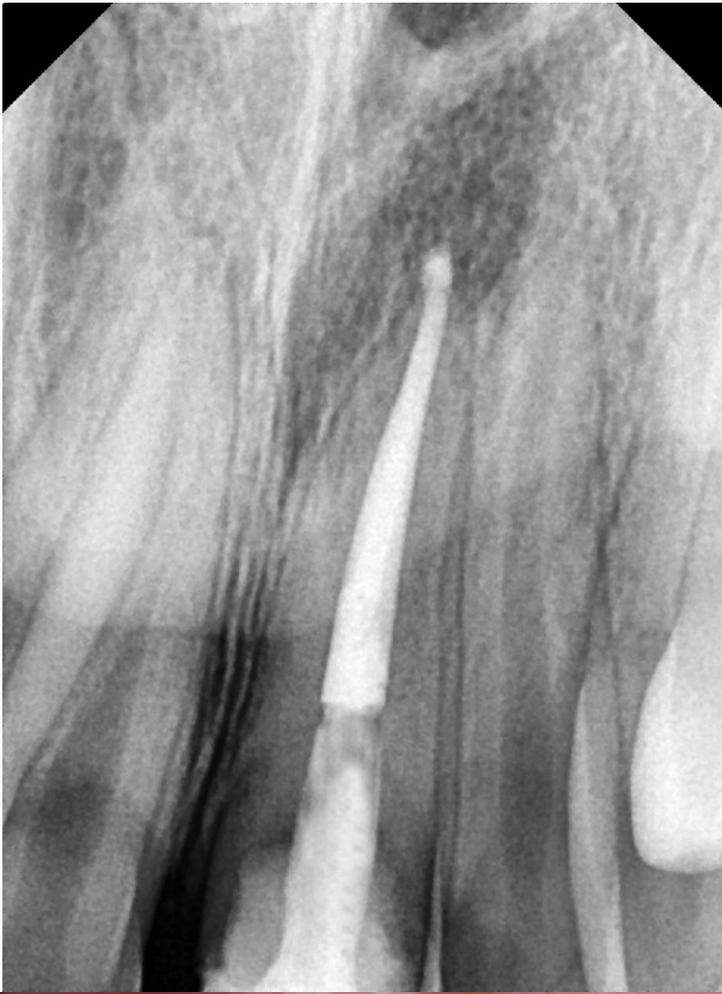
Recall 1 la 2 săptămâni.

Recall 2 la 6 luni
