## Case Presentation

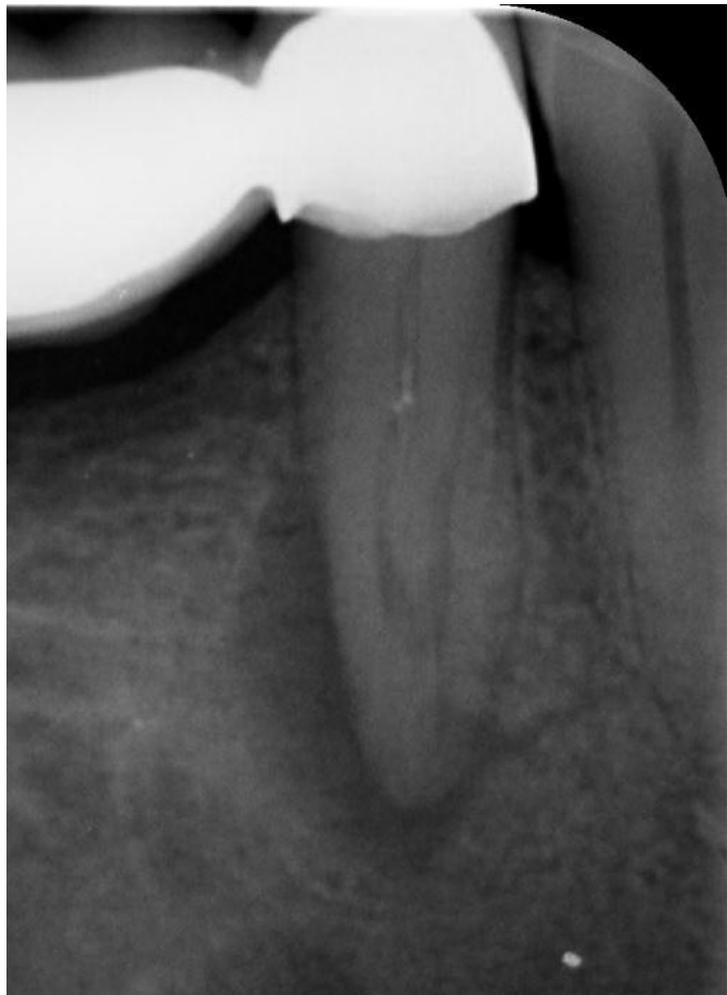
Figure 1

The periapical radiograph revealed an apical radiolucency of endodontic origin. Tooth 4.5 showed evidence of a previous, incomplete endodontic treatment.

The clinical and radiographic findings indicate an apical inflammatory process associated with insufficient prior root canal therapy, necessitating endodontic retreatmen

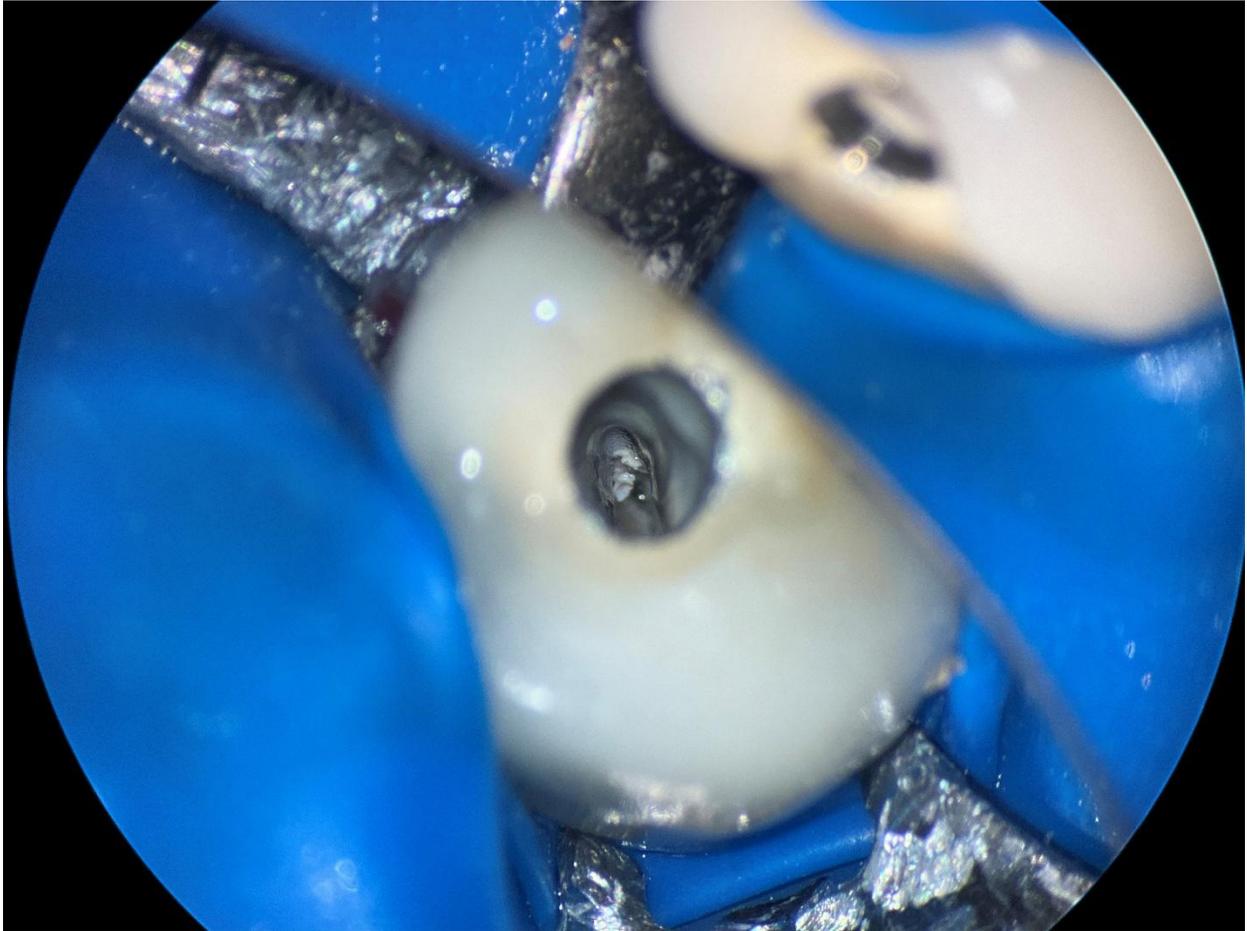
*Figure 2 Initial intraoperative aspect. Traces of gutta-percha can be observed.*

The endodontic retreatment was completed in a single visit. Following the administration of local anesthesia, rubber dam isolation was applied. Endodontic access was performed through the crown of tooth 4.5, as the patient declined replacement of the existing prosthetic restoration.

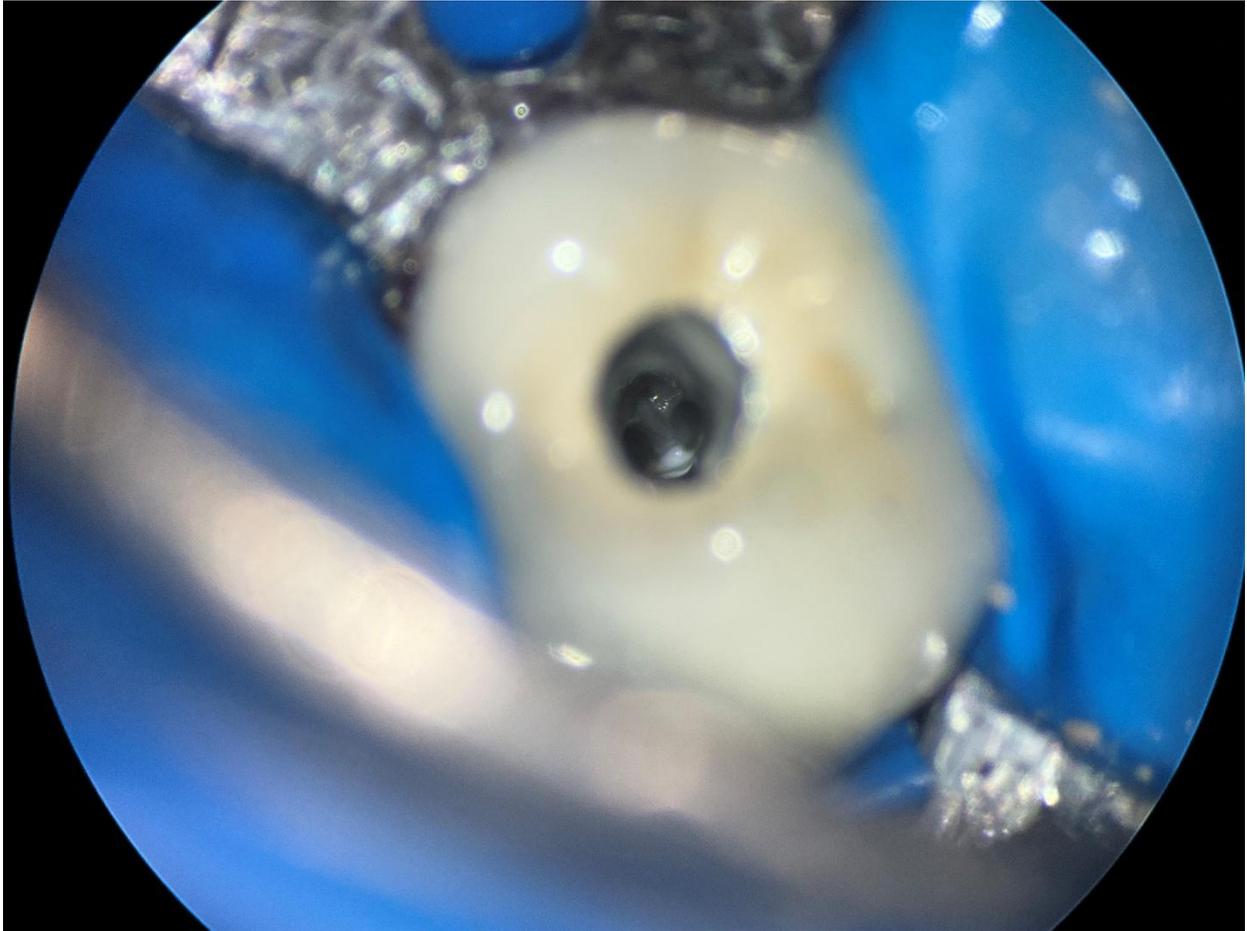
*Figure 3 Intraoperative photograph taken after instrumentation of the vestibular canals.*

Mechanical instrumentation of the root canal system was carried out using Rotate WDV rotary file system. Irrigation was performed with 5.25% sodium hypochlorite and EDTA, both solutions being ultrasonically activated with the Ultra-X device (Eightteeth) to enhance debridement and cleaning of the complex endodontic system.

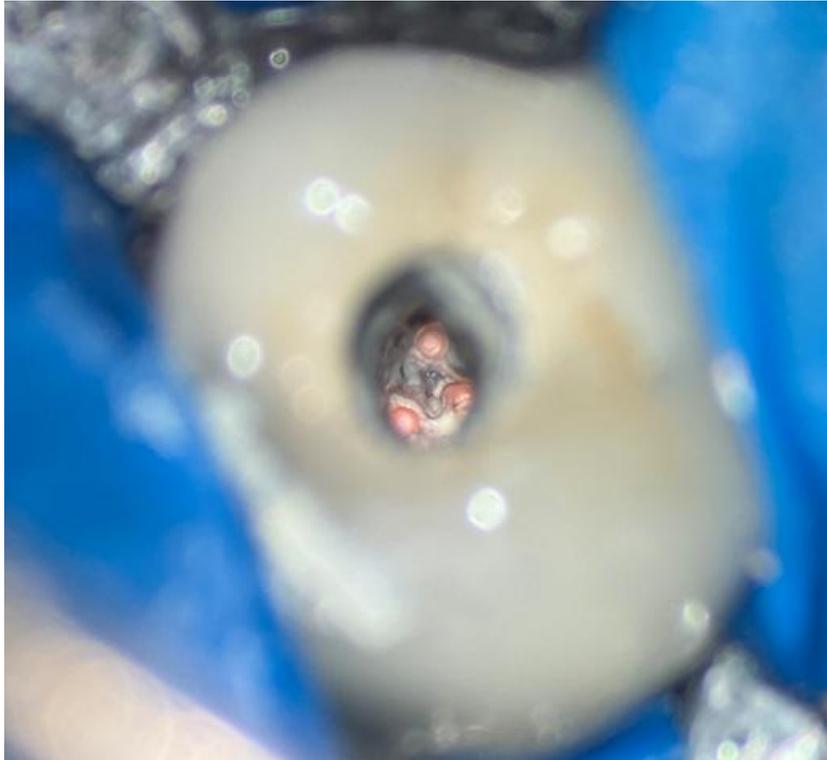
*Figure 4*

The root canal filling was completed using the warm vertical compaction technique with Ah plus sealer and guttapercha.

Coronal restoration was done using composite resin

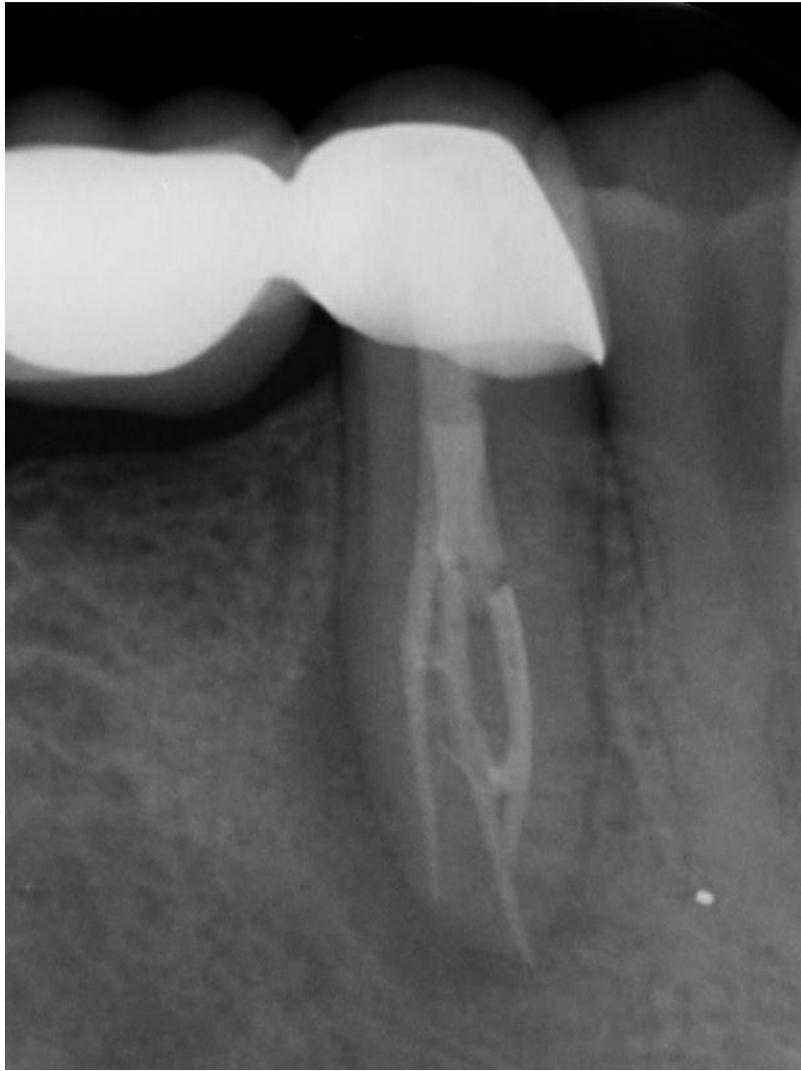
*Figure 5*

After completing the endodontic treatment, a post-treatment radiograph was taken in the clinic. The complex anatomy of the treated tooth can be observed.

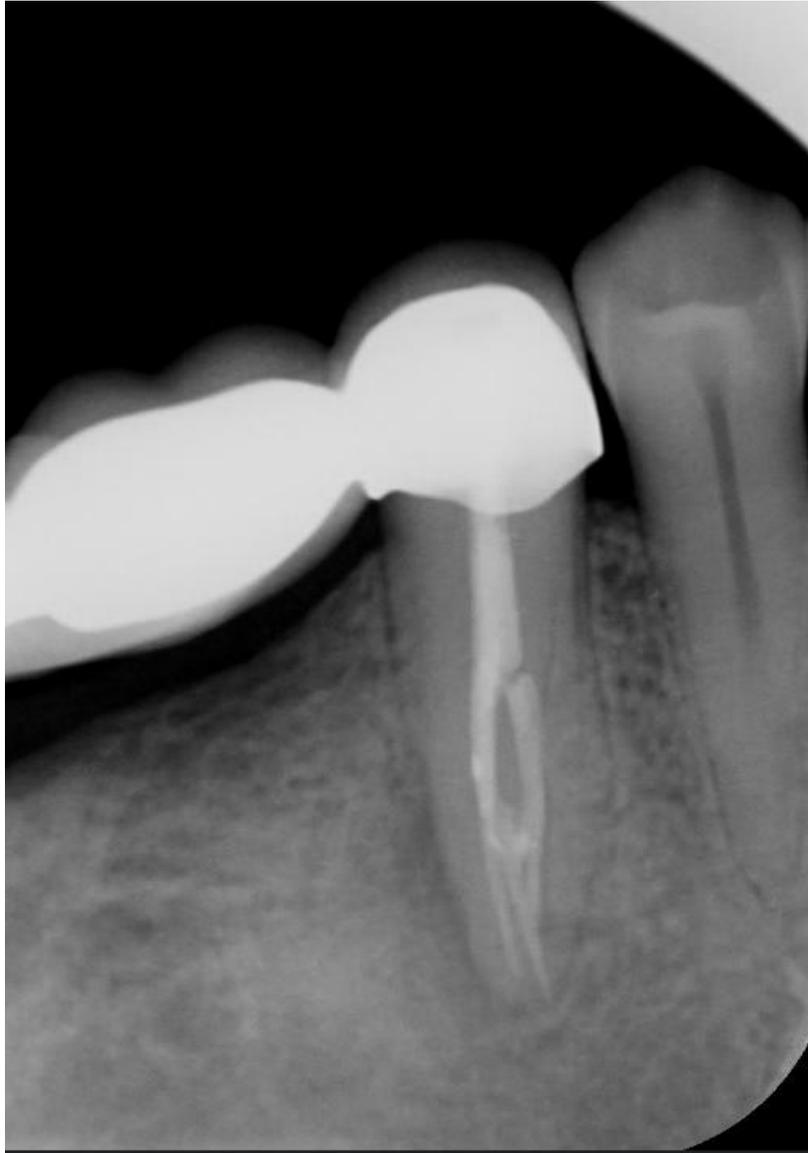
*Figure 6*

The patient returned for follow-up after 8 months, coinciding with the need for another endodontic procedure. Radiographic evaluation at this appointment allowed assessment of the periapical lesion's progression, revealing favorable healing.
